Progressive Collapse Analysis of an Existing Building

Kevin A. Giriunas*, Dr. Halil Seze

This research study investigated a structure's potential to fail due to progressive collapse. Progressive collapse in a structure occurs when major structural load carrying members are removed suddenly, and the remaining structural elements cannot support the weight of the building and fail. This failure usually occurs in a domino effect and leads to a progressive collapse failure in the structure. This experiment involved testing of a steel building scheduled for demolition in Northbrook, Illinois. The demolition team tore out four selected columns from the building to simulate the sudden column removal that leads to progressive collapse. The author instrumented the beams and columns in the building, managed the testing and analyzed the recorded data. The strain values recorded in the field were compared with the results from a computer model of the building. The percent error between the calculated and measured strains in a selected column was 21%. The computer analysis conducted in this research was based on linear material properties. The ultimate goal of this ongoing progressive collapse

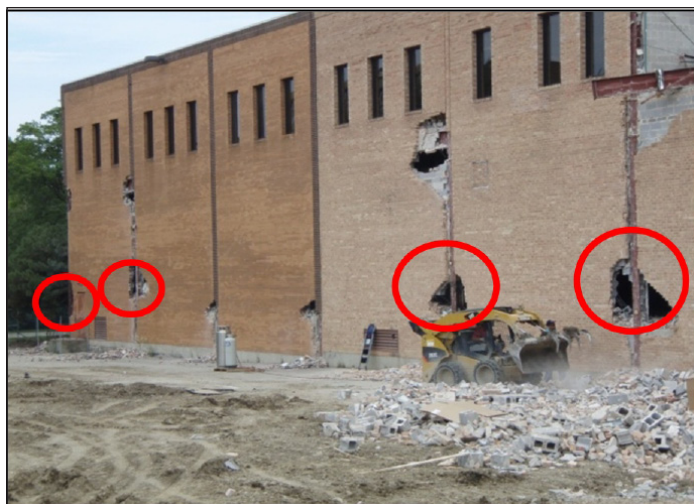
Figure 3. The Circled Columns on the North Side of the Building were Removed During the Experiment.

The experiment involved recording the strain on various structural members as four columns were removed from the north side of the building (Figure 3). The Environmental Cleansing Corporation was hired to demolish the Bankers Life and Casualty Company insurance building. They agreed to help with the study, tearing out the four columns as specified in this research using GSA (2003) as a guideline.

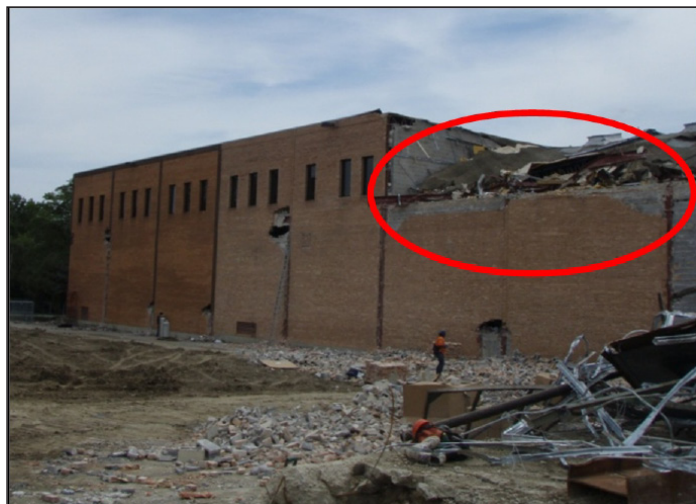
Figure 4. The Rubble Mass is Circled on the North Side of the Bankers Life and Casualty Company Building.

Prior to removing the columns, the demolition team tore down the second floor near the northwest corner of the structure due to a miscommunication between the owner and the demolition team. As a result, all of the building materials remained on the second floor concrete slab. The joists, bridging joists, roofing, bricks, tie rods and concrete masonry units (CMU) created a rubble mass on the second floor slab. This rubble spanned the area of four bays east from the northwest corner and approximately two bays south, resulting in a slightly different loading scenario for the four columns nearest the northwest corner. Figure 4 shows the rubble mass at the north side of the building.

floor was collapsed by the demolition team (Figure 4) prior to the first column removal; the GSA guidelines required all dead loads be multiplied by a factor of two (Equation 1). Also, the structure could not redistribute the gravity loads as easily because it was a two-story structure, half of the second story was collapsed and large spans were present between columns. A taller structure probably would be able to distribute gravity loads to more members and would generate smaller DCR values as found in Sezen and Song (2008).

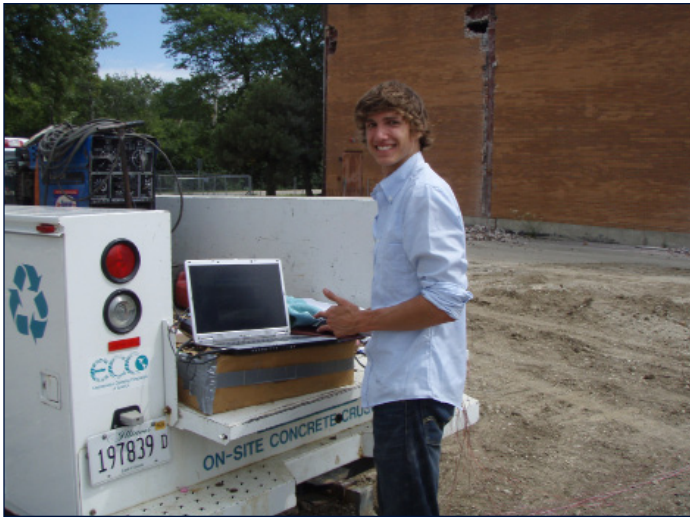
Figure 7. Computer Station and Data Acquisition System. from GSA (2003)] presented in Table 2.

The strain gauges were attached to a portable data acquisition scanner system and laptop. During the column removal process, the computer measurement scanner and laptop recorded all nine strain gauge readings simultaneously.

to three feet. The demolition team then melted a hole in the northern facing flange of each column between the torched lines. A chain was then attached to the hole and the column was pulled out by a large backhoe. Figure 6 shows the column torching and removal order, Figure 7 displays the computer station set up at the demolition site, Figure 8 shows Column 16C being torched, Figure 9 shows a torched column with a chain attached and Figure 10 shows Column 11C being removed.

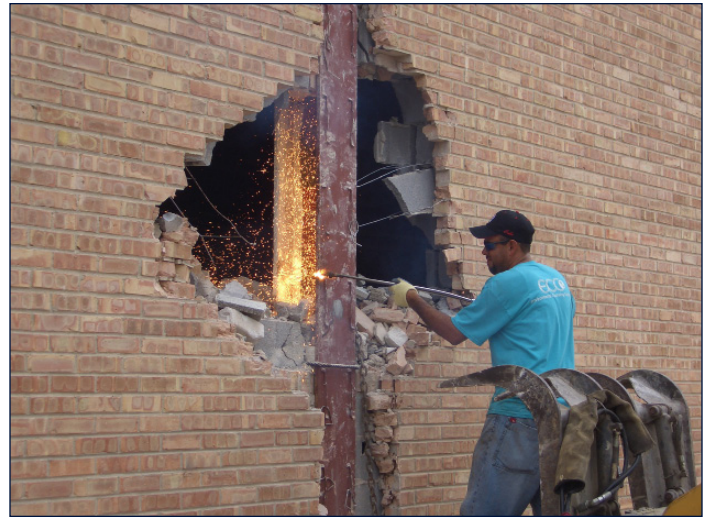
Figure 8. Column 16C Being Torched.

During the column removal process, each column was weakened by a blow torch prior to its removal for safety reasons. During the torching process, the demolition team melt nearly through each column's cross section at two points above the strain gauges. The distance between the torched lines on each column was approximately two

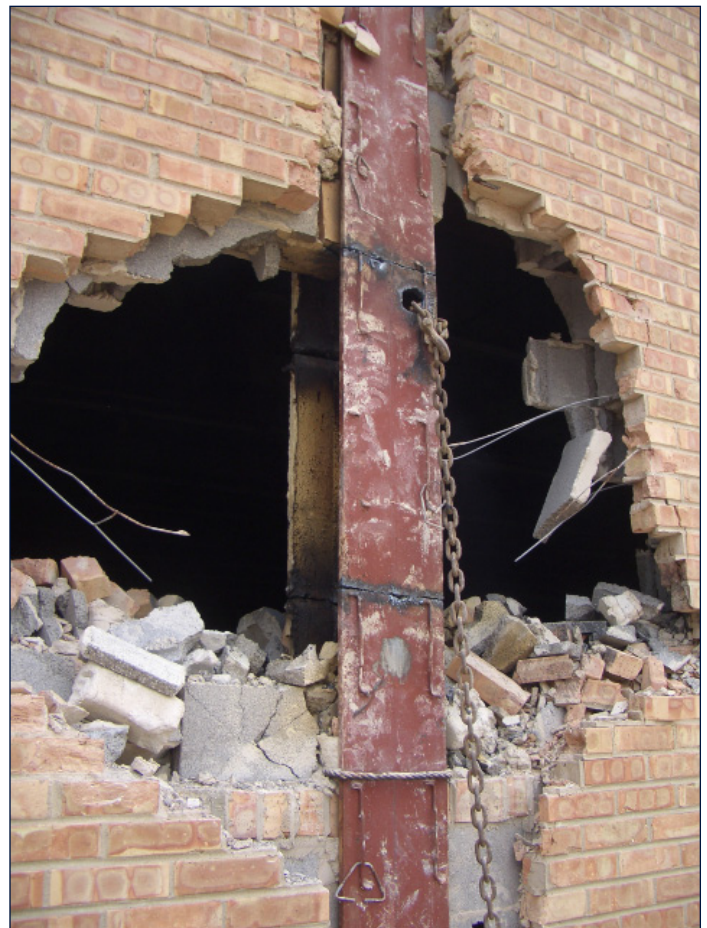
Figure 9. Torched Column Ready to be Pulled Out.

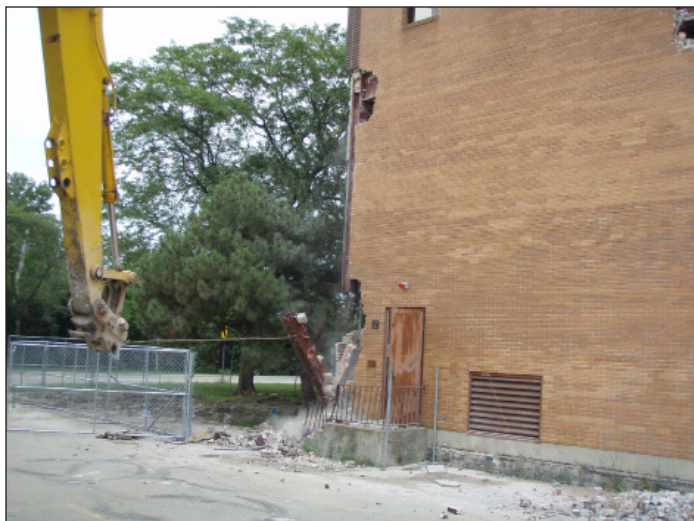
Figure 10. Torched Section of Column 11C Being Removed.

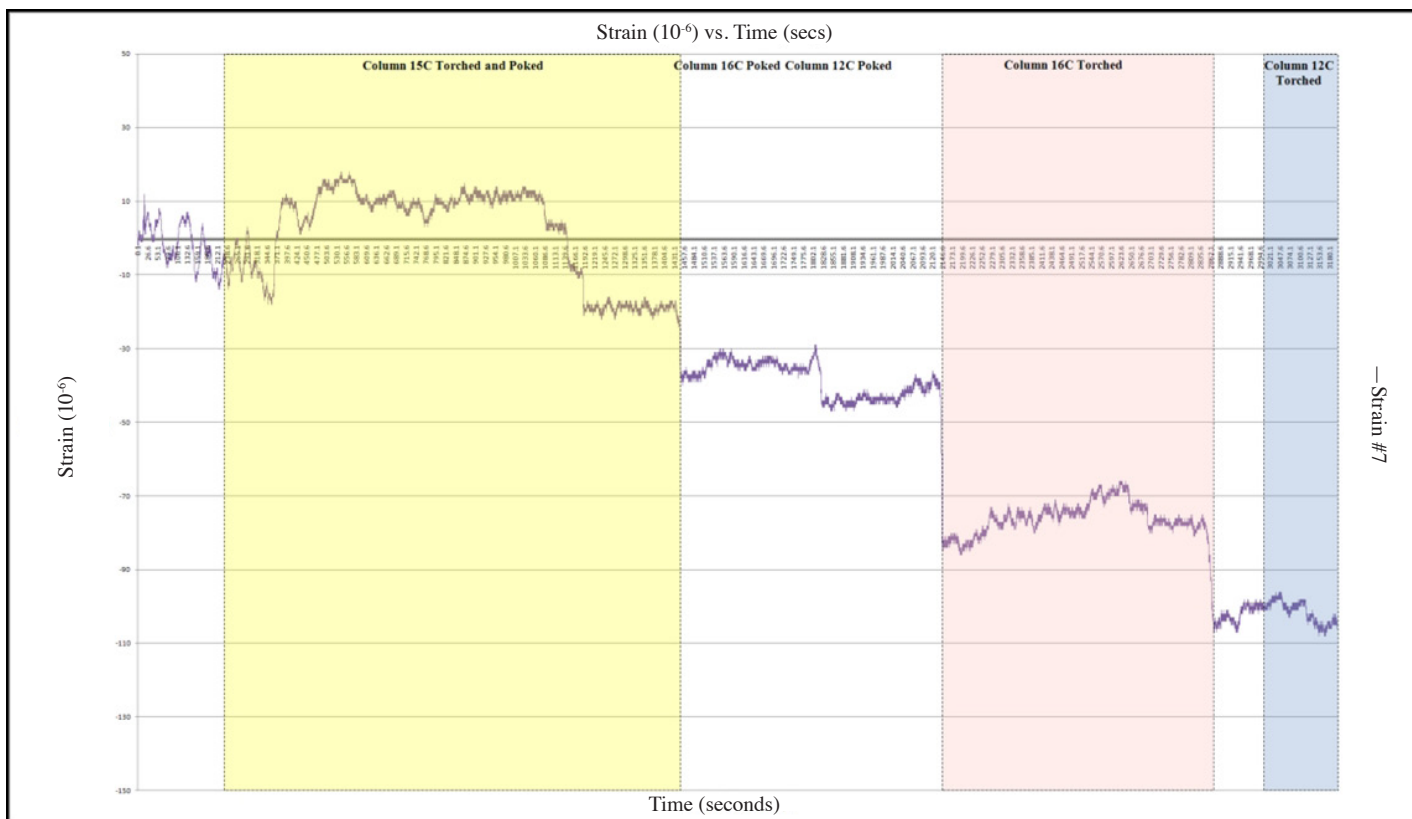
Figure 11. Strain versus Time Chart for Strain Gauge 7: Measurements during Torching (Time: 0-3200 seconds).

The strain values were recorded every tenth of a second during the column removal. Figure 11 shows the strain recorded in the field from a single strain gauge during each column torching and removal.

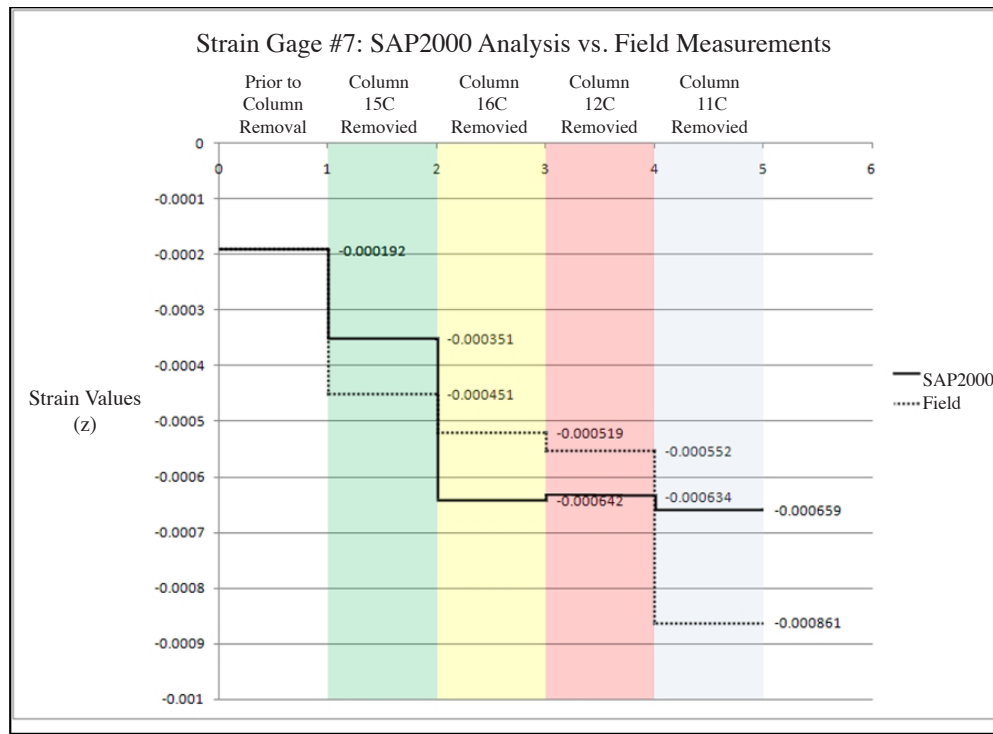
Figure 17. SAP2000 and Field Strain Values Shown for Strain Gauge 7 (21% Error between SAP2000 Results and Actual Measurements).

The strain (ϵ) for Strain Gauge 7 on Column 14C was compared with the generated SAP2000 ϵ values (Figure

17). Strain Gauge 7 was selected for this experimental study because it was believed to have recorded the most consistent and accurate data in the field. Figure 17 shows that the strain values recorded in the field from Strain Gauge 7 had an average 21% error between the field and SAP2000 results. These values were very close considering all the possibilities for error. The exact time of each column torching and removal was not recorded, the exact locations of strain gauges were not recorded and the demolition atmosphere could have caused recording discrepancies.

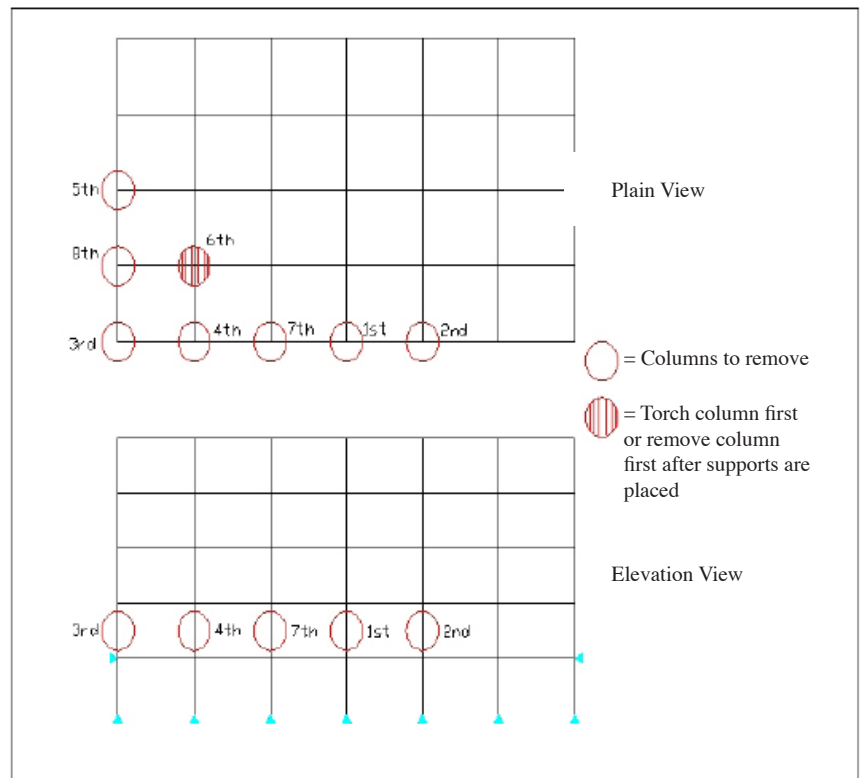
Figure 20. Suggested Order of Column Removal for the First Floor.

In this study, a general procedure was developed for removal of first story columns from a regular frame building. The procedure illustrated in Figure 20 demonstrates the order for which columns should be removed. For safety reasons, the columns all have to be torched first, and the columns should be removed in the same order. Following the procedure previously described, the column circled 6th should be torched first. Prior to torching, the 2nd floor has to be supported near the column circled 6th (Figure 20). Steel supports being developed will support the weight of the structure above the interior column circled 6th, and a jacking system will hold the supports in place. The interior column is to be torched and removed while the support mechanism supports the weight of the structure above the column. The jacking system will be disengaged once the interior column is to be removed.

The interior column circled 6th will be considered removed once the jacking system is disengaged. The columns

circled 7th and 8th are optional to be torched and removed. Also, it may not be possible to remove columns circled 5th and 8th if the left side of the building is not accessible for testing.
